HERKIMER COUNTY COMMUNITY COLLEGE MASTER PLAN

# **FACILITIES MASTER PLAN**

22 March 2017

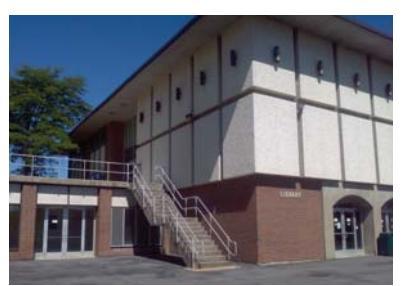
Ronald F. Williams Library From the Upper Campus Quadrangle

**Building Envelope:** The majority of the building's envelope is typical of legacy construction, accounting for approximately seventy five percent of the building perimeter. The south east facade was part of the 2008 renovation and is a metal panel system with aluminum curtain wall fenestration. In general the building perimeter walls are in good condition. The legacy windows and mansard soffits are in serviceable condition, exhibiting staining and fading along the outboard edge of the soffit panels, localized surface marring and the window infill panels discoloring around the perimeter.

The Library has two roofing systems. The legacy building has a multi-ply modified bitumen roofing system. This is a replacement roof, installed in 2005. The 2008 addition has a single ply EPDM membrane roofing system. In general the roofing systems appear to be performing as expected, with the bitumen roof approaching the end of its warranty period. This roof had been leaking; however, this was not a fault of the roofing system per se and was rectified by the replacement of the associated roof top exhaust fan.

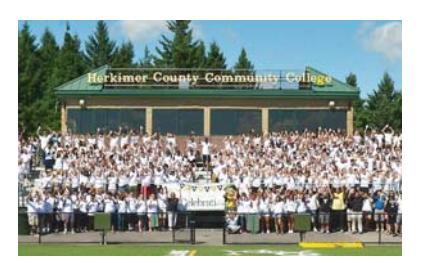
Stadium Pressbox Building

**Interior conditions:** In general the interior spaces within the Press box are similar and are in similar condition. The flooring is carpet, the exterior walls painted concrete masonry units and the interior partitions painted gypsum board drywall. In general these are all in good condition. The ceilings are a 2x2 suspended acoustical panel system in serviceable condition.

Exceptions to this include the carpet flooring at the entrance hall, which is in poor condition because of the water intrusion noted above. Second, the ladder and painted gypsum board enclosure at the roof access ladder are also in poor condition, exhibiting signs of water damage. It should also be noted that the roof top viewing platform is not handicap accessible.

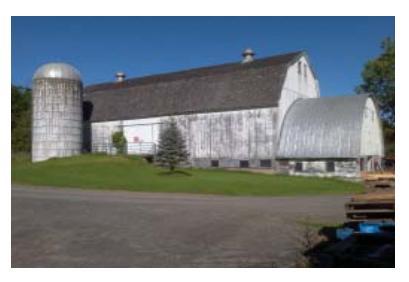
Old Storage Barn

**The Barn:** Located on the north side of the campus is a large barn with a silo. It is wood framed construction, with wood siding, asphalt roof and set on a concrete foundation. This structure has been condemned and cannot be used.

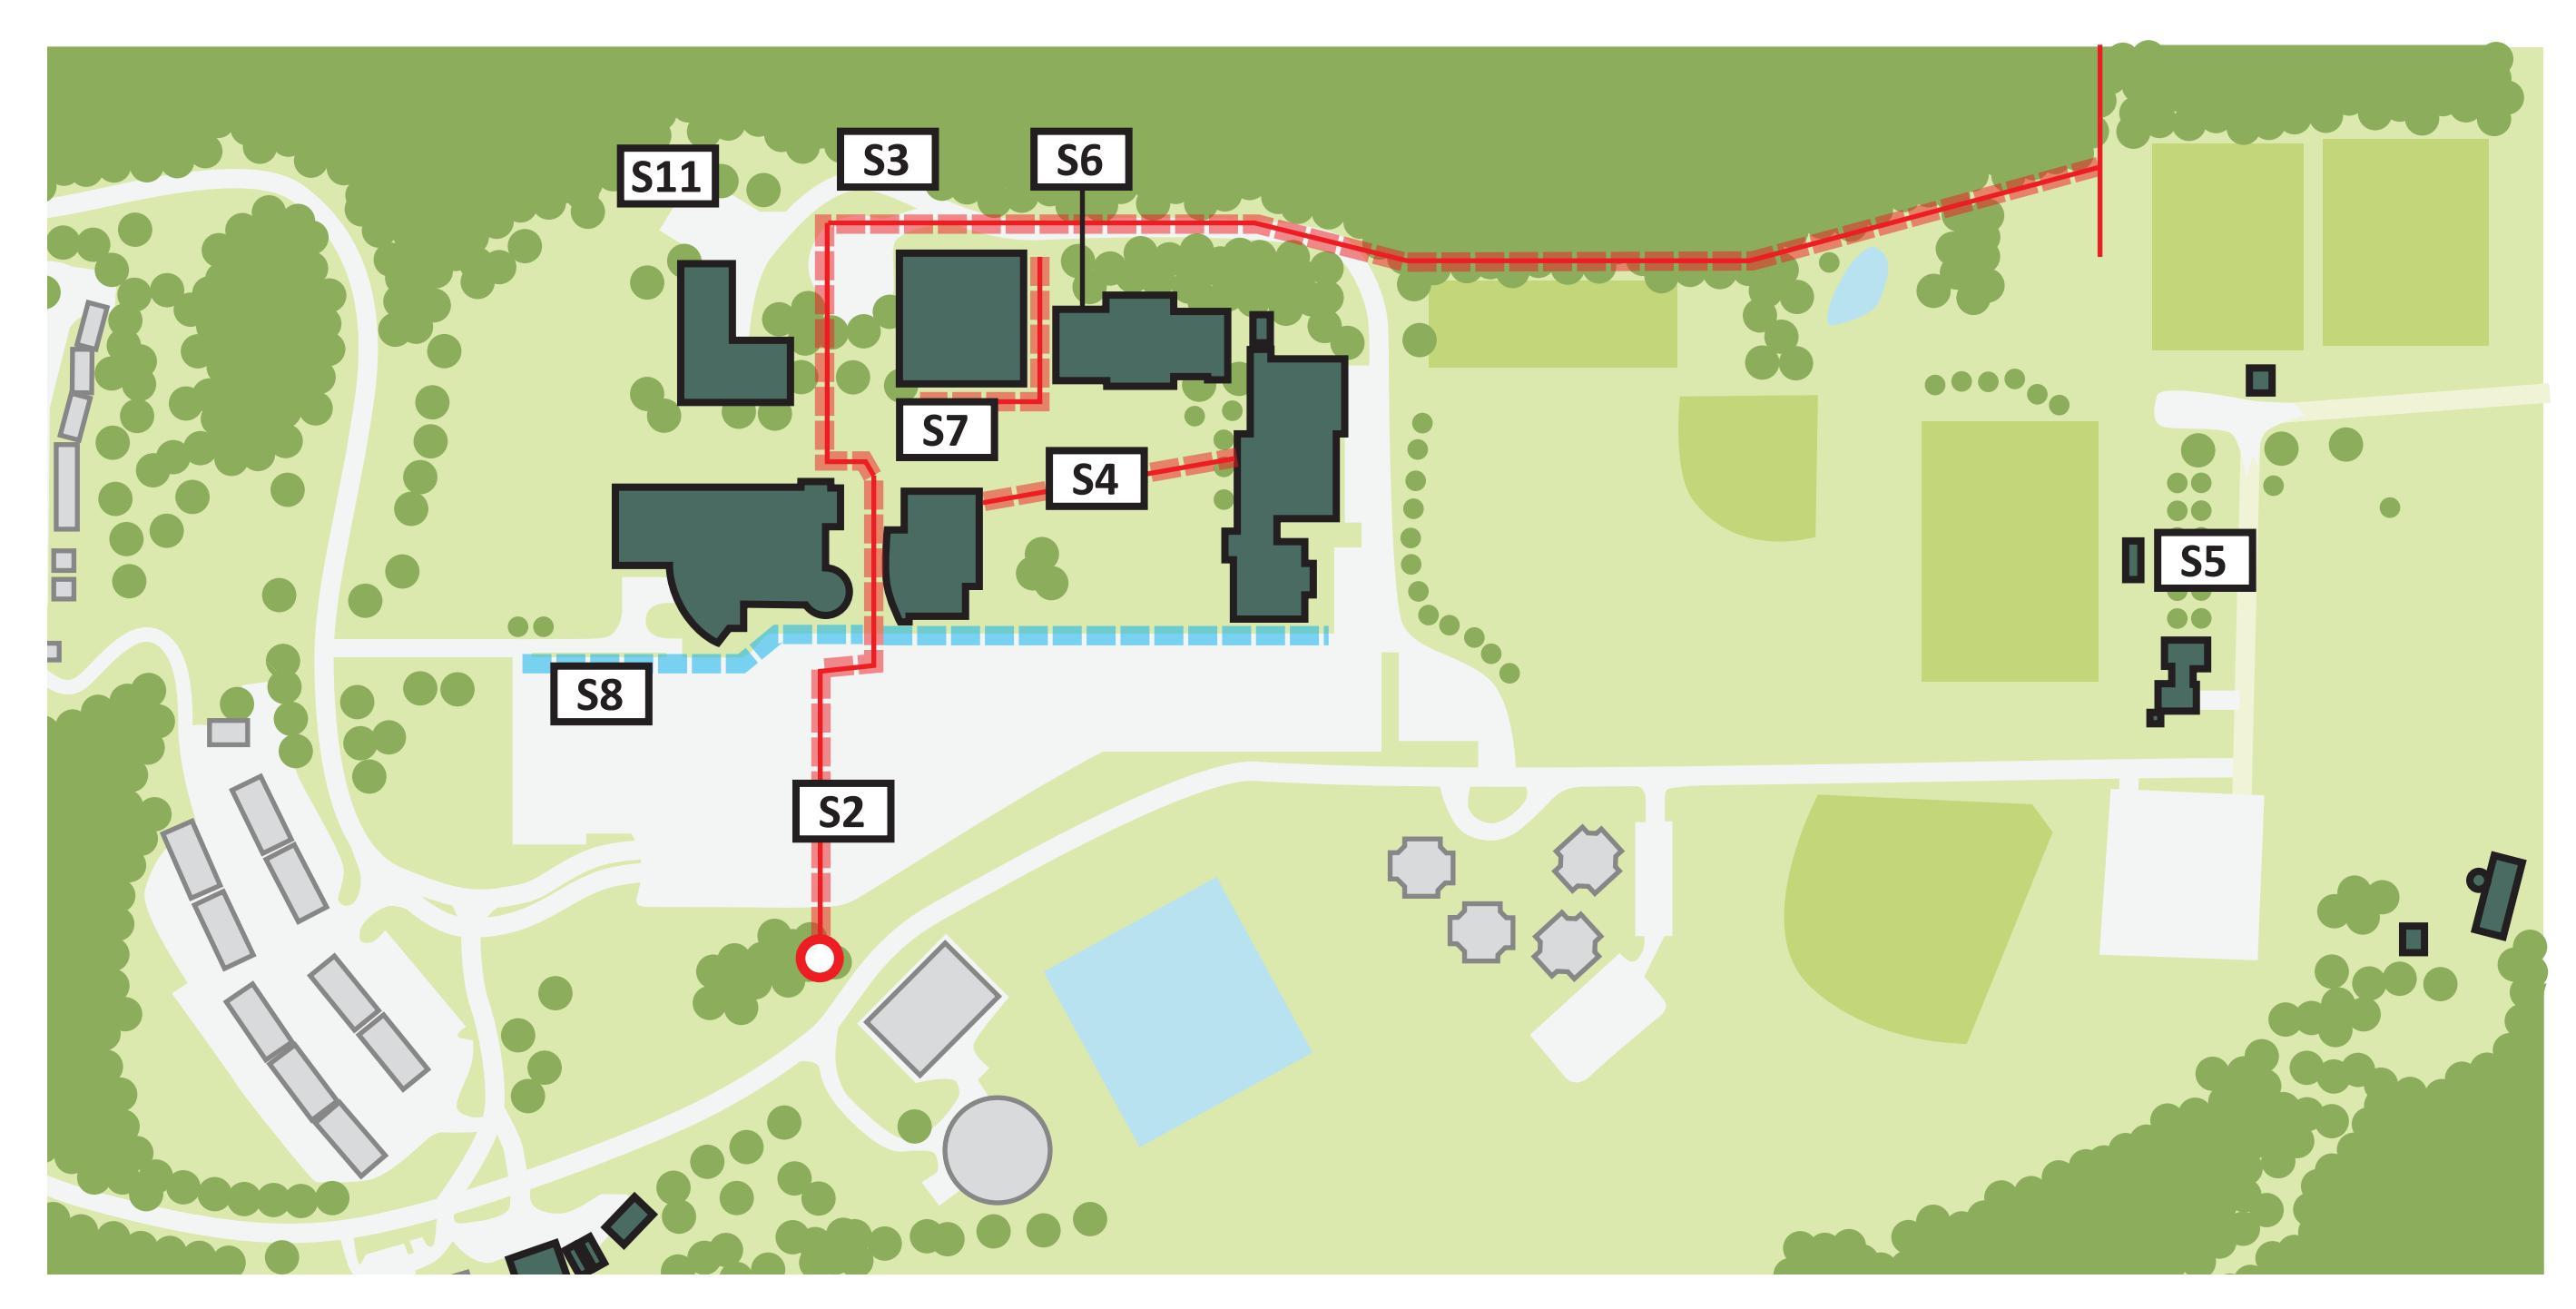
# **Site Infrastructure** Remediation Work

- **S2** Retrofit Cast Iron Water Main
- **S3** Remediate Storm Water Outfall Erosion behind Johnson Hall

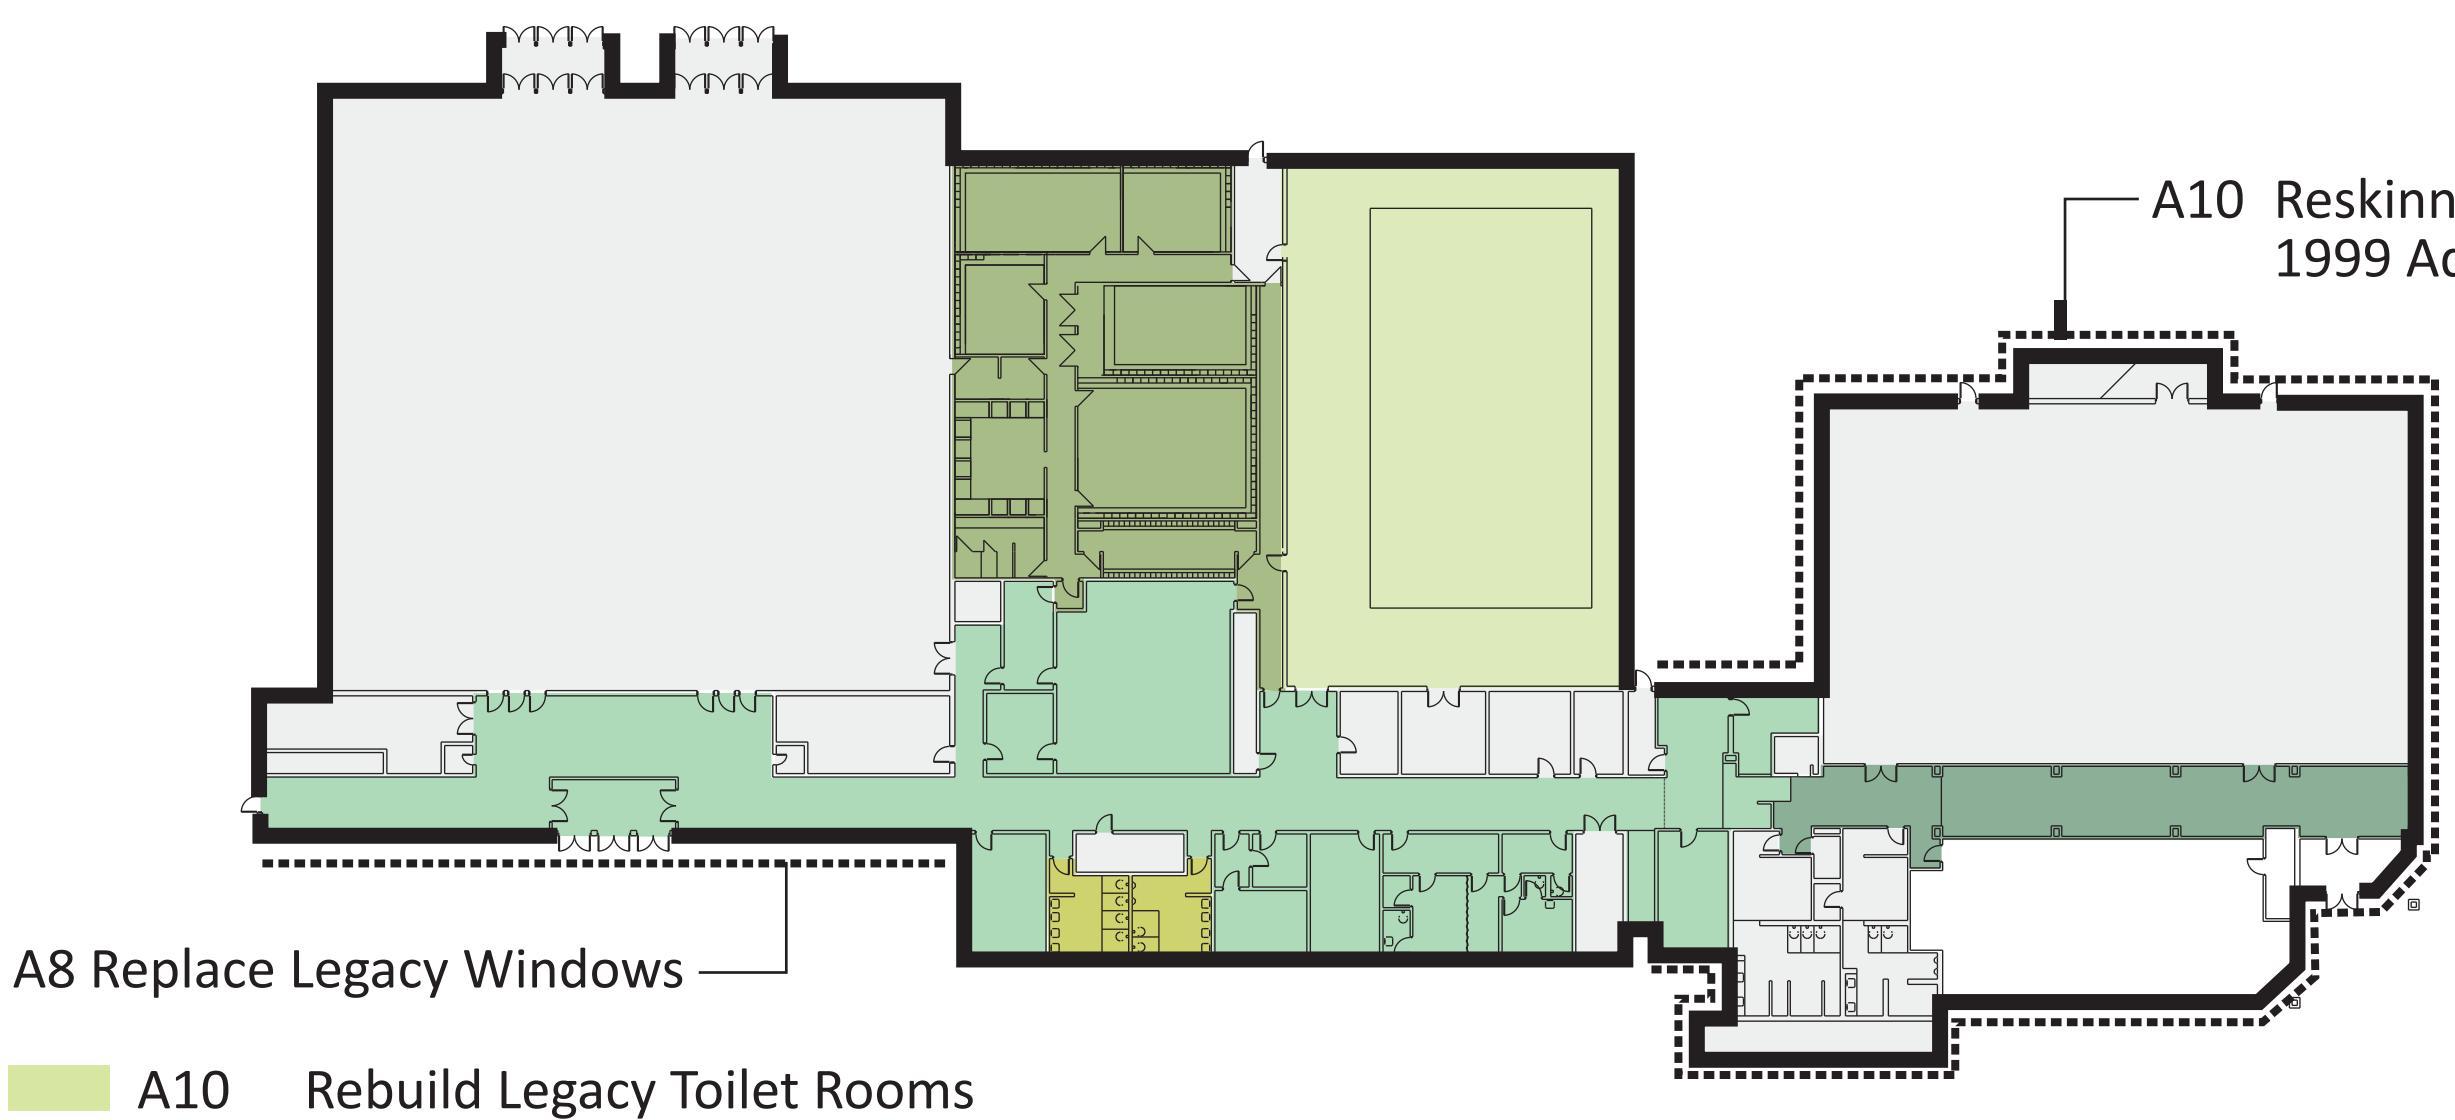
**PE Building** Main Level

- **Replace Ceilings and Lights** A12
- A18 Campus Wide Door Replacement
- Renovate Locker Rooms A5.2
- A5.3 Pool Renovations: Lighting and Deck
- A5.9 Replace Lobby Floor
  - No Work

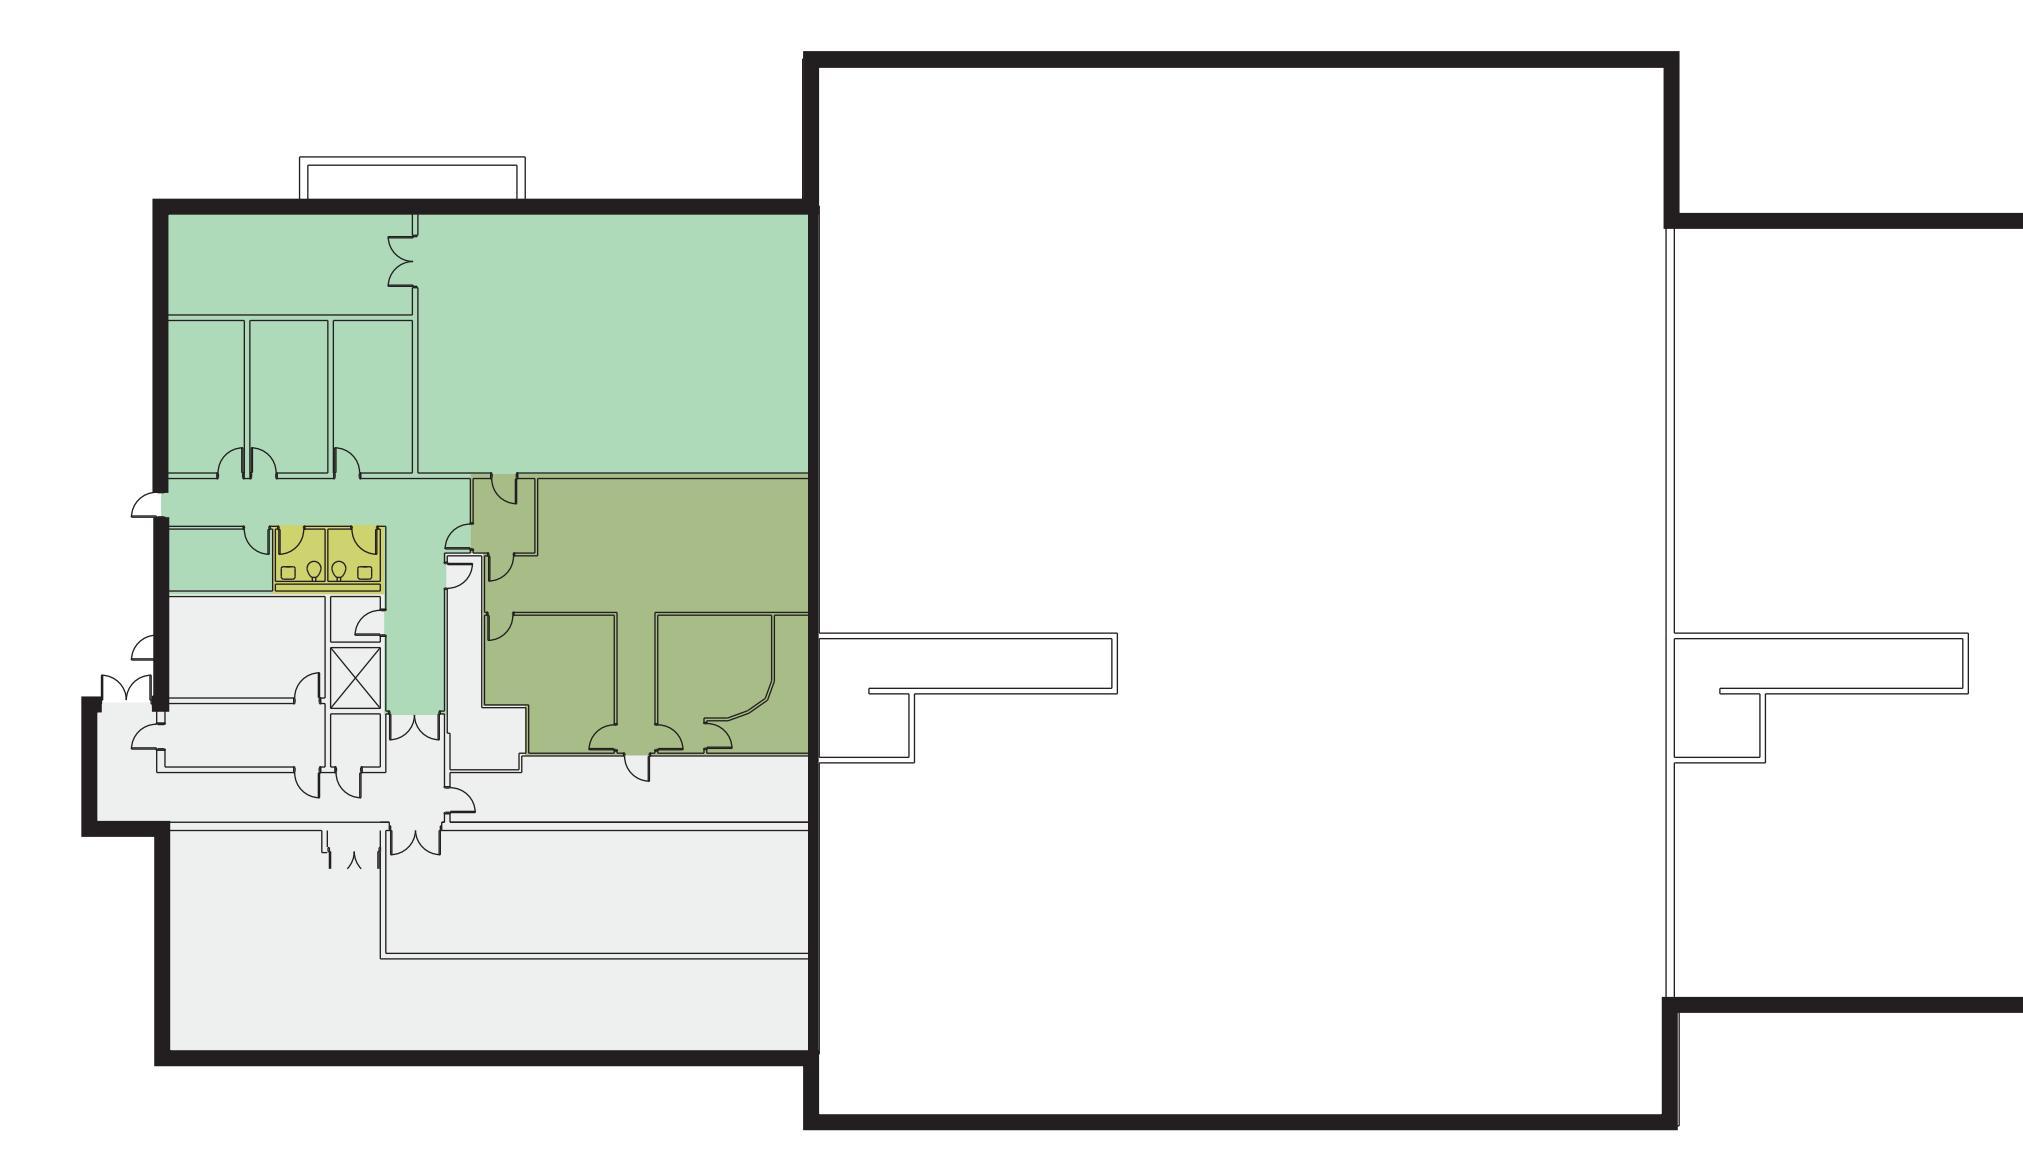
TC Building Lower Level

- A10 Rebuild Legacy Toilet Rooms
  - A12 Replace Ceilings and Lights
  - A18 Campus Wide Door Replacement
- A9 TV Studio Flooding Remediation
